Inspection Report

Subject: Knox County Erickson Farms
(Altona) Reconnaissance Report

Date: May 2, 2012

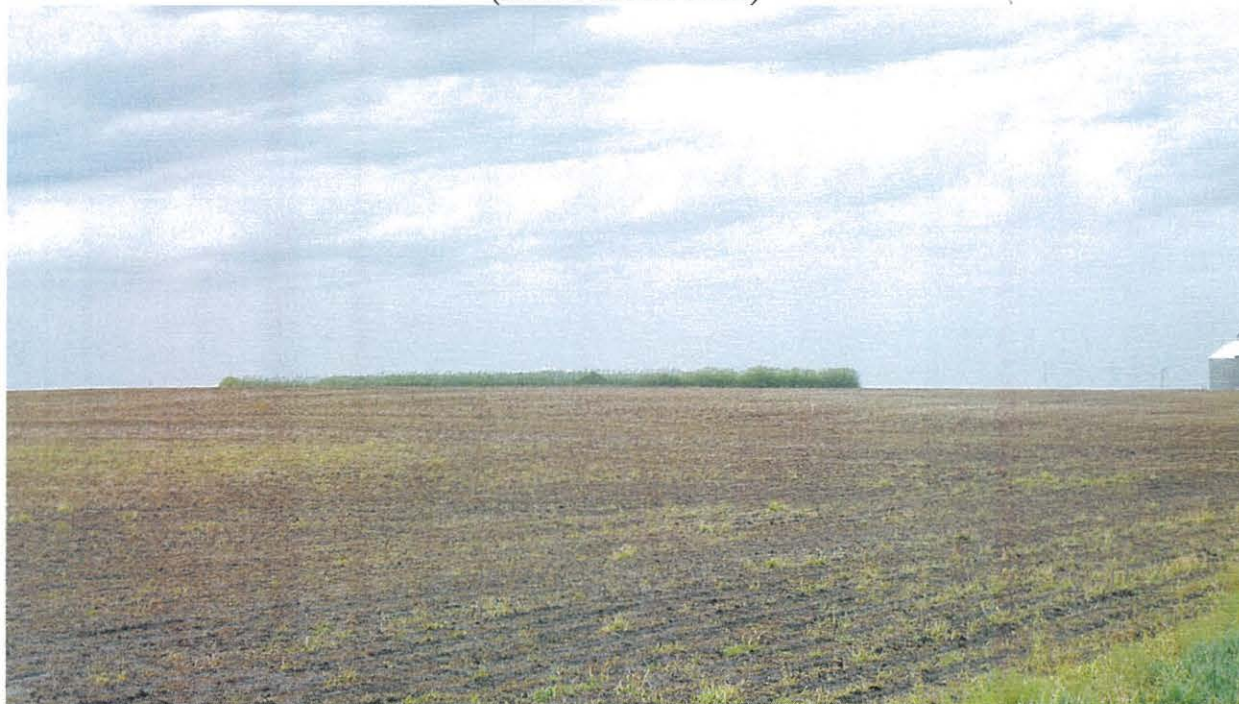
Figure 2. Plan View From Google Earth of Erickson Farms near Altona in Knox County on May 2, 2012.

The facility is located near the intersection of Knox Highway 3 and Knox Road 2900 N. The facility is well camouflaged by thick vegetation that appears to be a Vegetative Environmental Buffer (VEB) made of hybrid willow trees and a few newly planted rows of pine trees. This VEB can be seen in the plan view, Figure 2, and surrounds the facility completely. The roofs of the two total confinement buildings have also been colored green so that they blend in with the vegetative buffer, see Photograph #1.

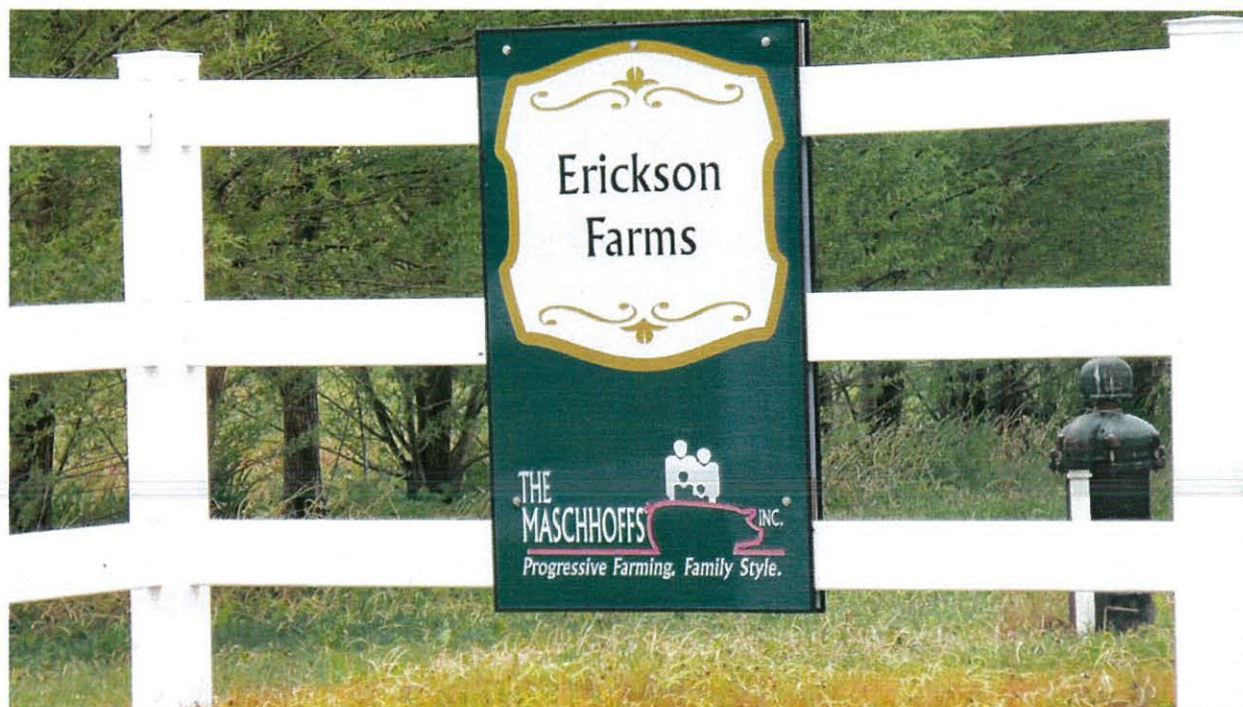
Photograph #1. View of Erickson Farms from Knox Highway 3, view is northwest.

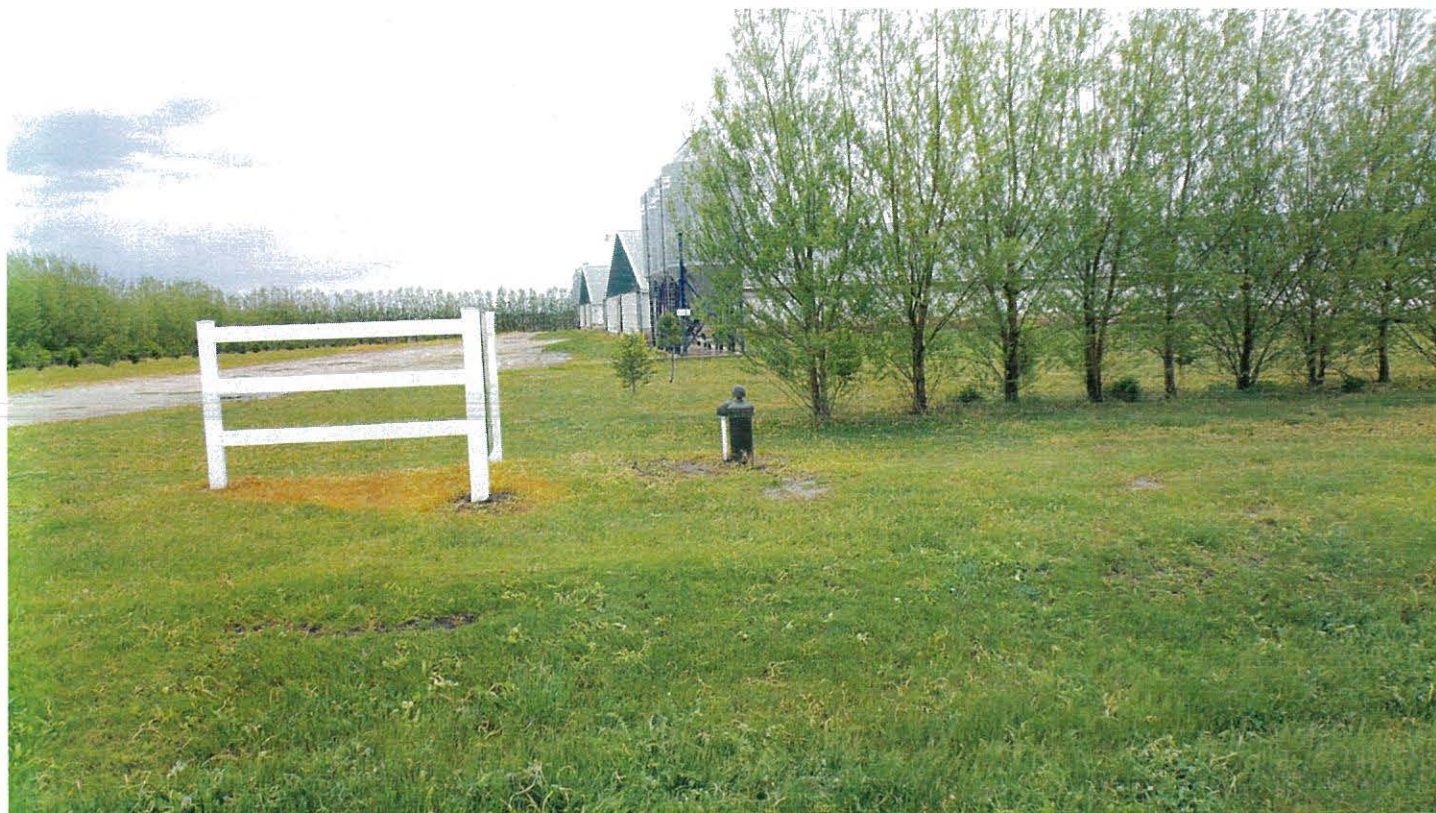
Photograph #6. View of facility from Knox Road 2900 N, view is south. Well head for facility is shown.

This site appears to be composed of two large total confinement buildings. There is a well head that was observed near Knox Road 2900 N on the north side of the facility. Two LP tanks were also observed on the north side of the site.

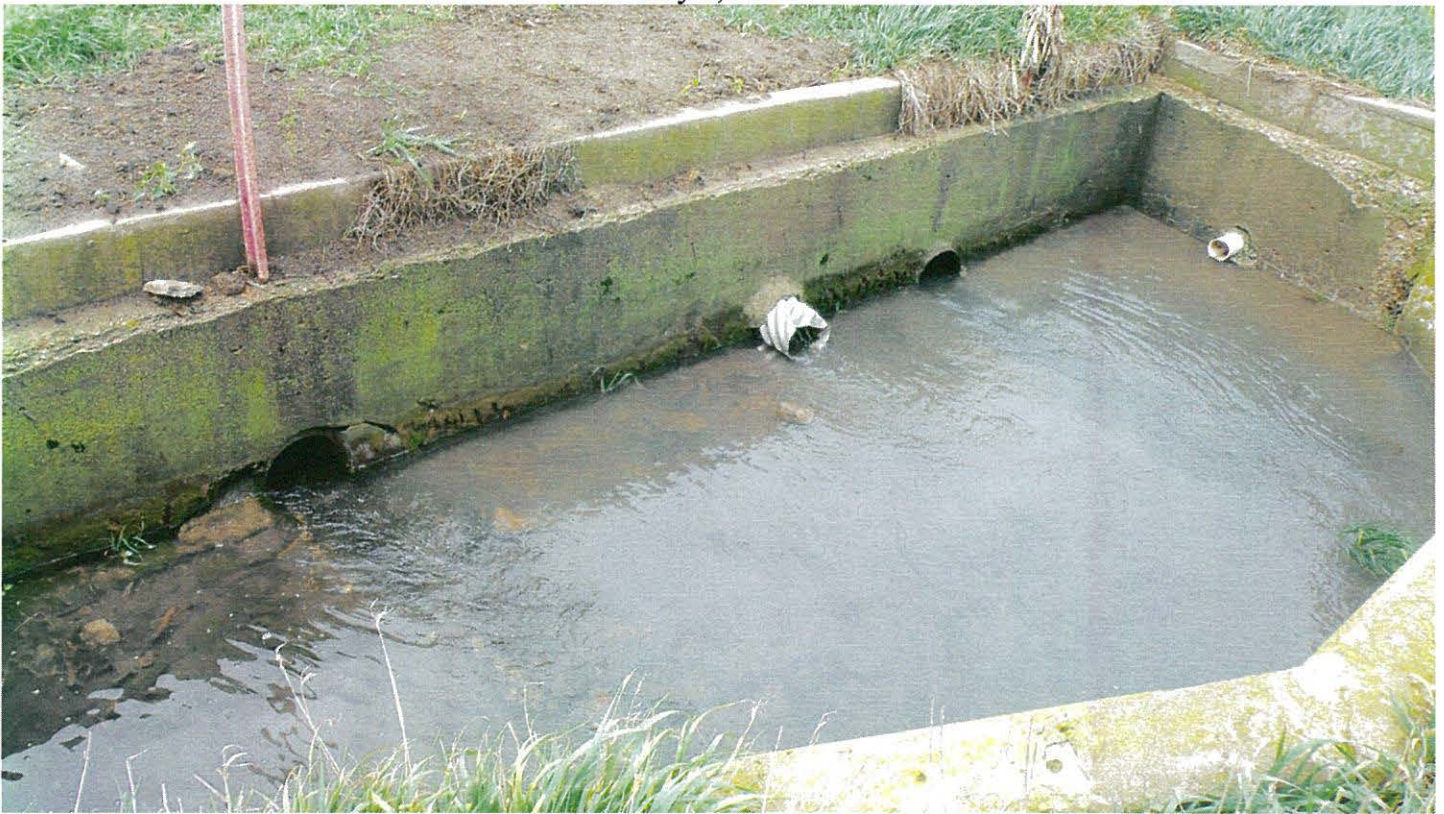
Photograph #7. Tile discharge location off of Knox Highway 3, southeast of facility. Believed where facility perimeter tiles would discharge. Water has black/dark brown coloration.

Southeast of the facility on the west side off of Knox Highway 3 was a tile discharge location. This location is believed to be where the facility's perimeter tiles would discharge to. This discharge location was observed with black/dark brown water being discharged from the tile for a few minutes, but then the discharge returned to clear.

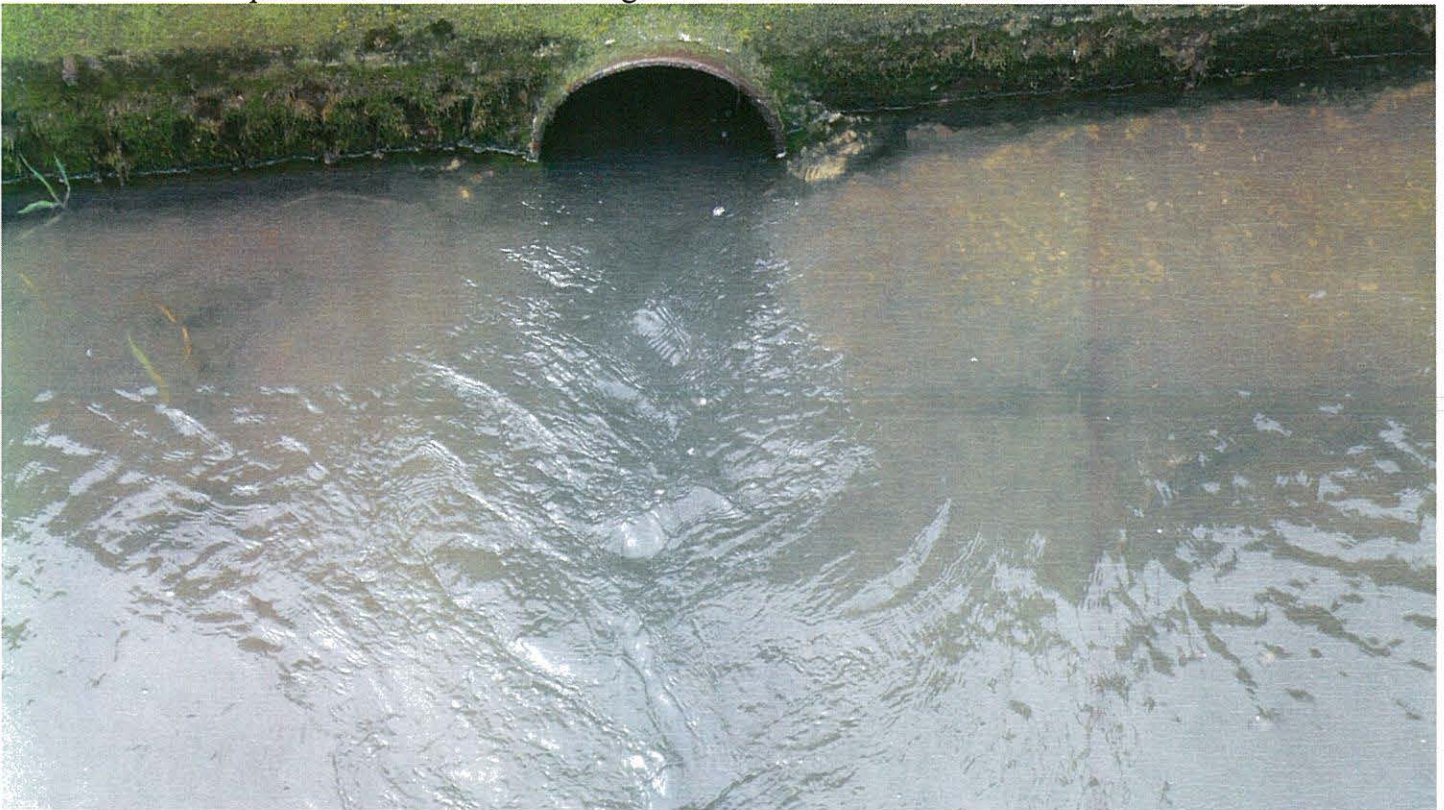
Photograph #8. Close up of tile discharge with black/dark brown water discharge.

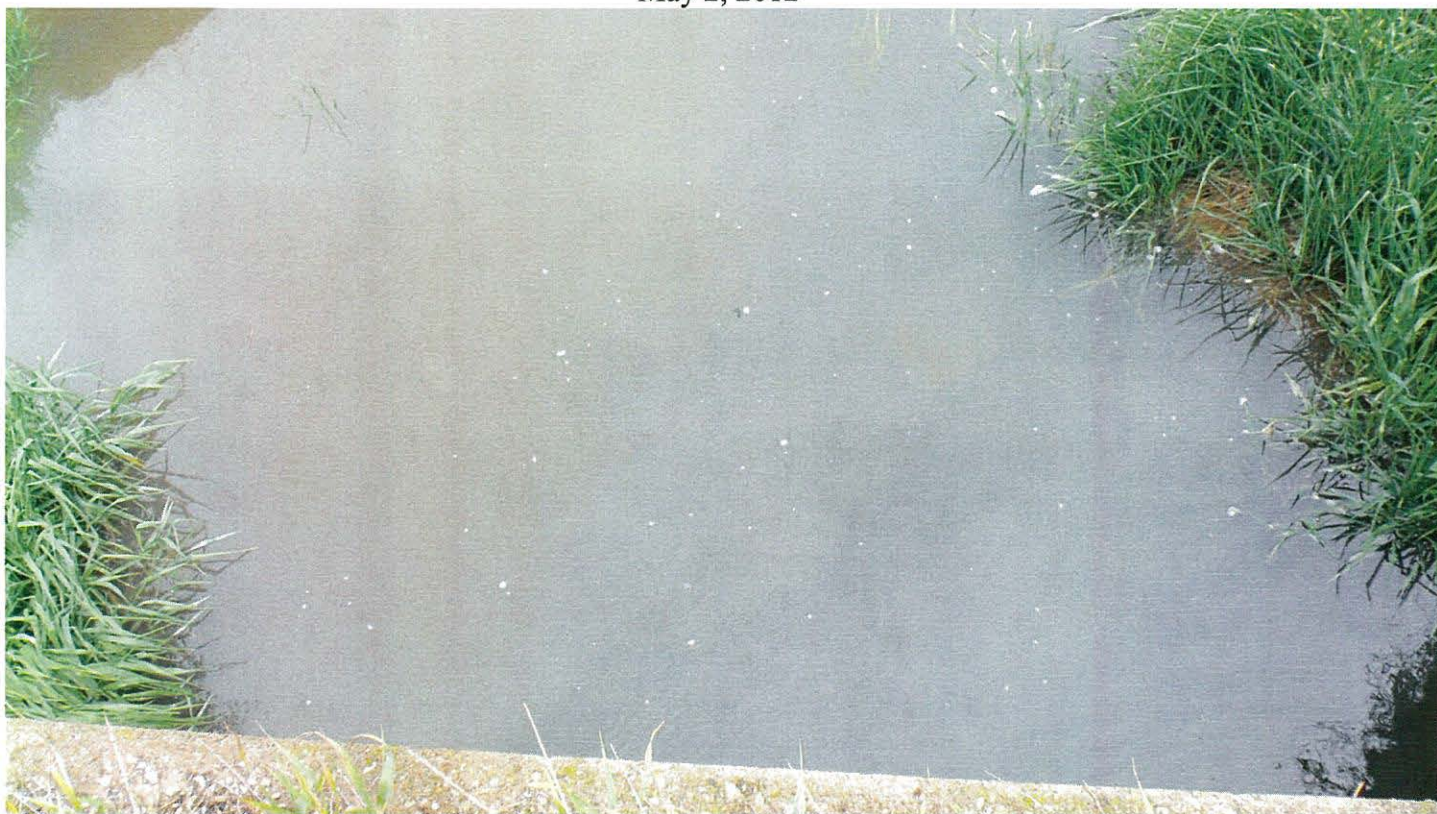
Photograph #9. . Close up of tile discharge with black/dark brown water discharge.
